REPORT ON THE
INSPECTION OF
NEW JERSEY STATE
HIGHWAY BRIDGES

REPORT ON THE INSPECTION OF NEW JERSEY

STATE HIGHWAY BRIDGES

Inspection was made during the winter of 1958-59 of 44 bridges geographically situated in all sections of the state.

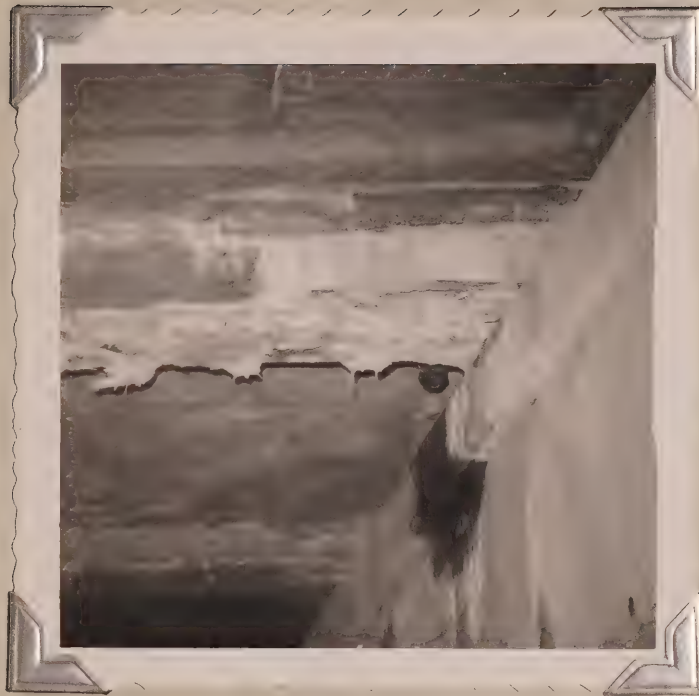
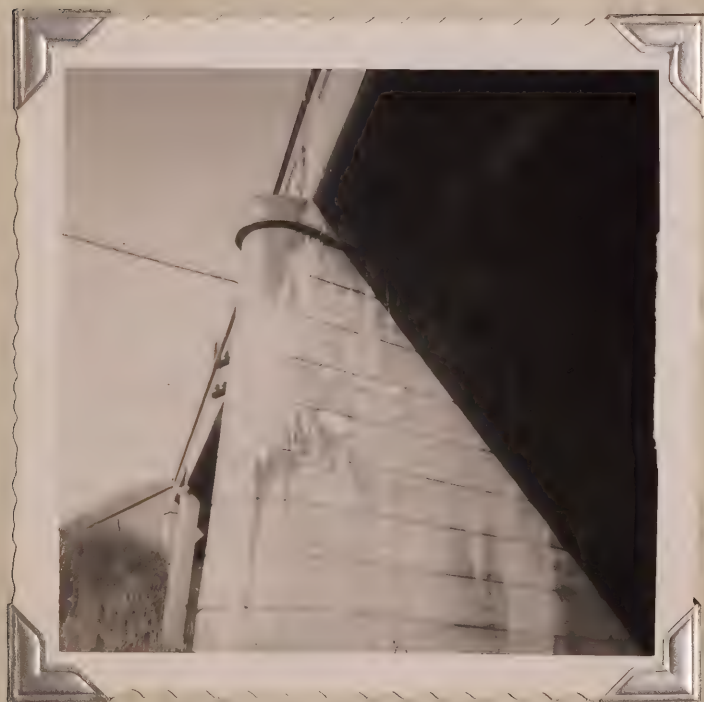
BRIDGE NO. 3

Condition - Abutments in good condition. Considerable crystalline deposits on underside of bridge beams. Piers are cracked, concrete has spalled and is disintegrating. Some leeching at the top of the exterior beams. South face of center pier has been repaired. Horizontal crack occurs at coping of southwestern wing wall. Photos show piers and girder encasement near the support.

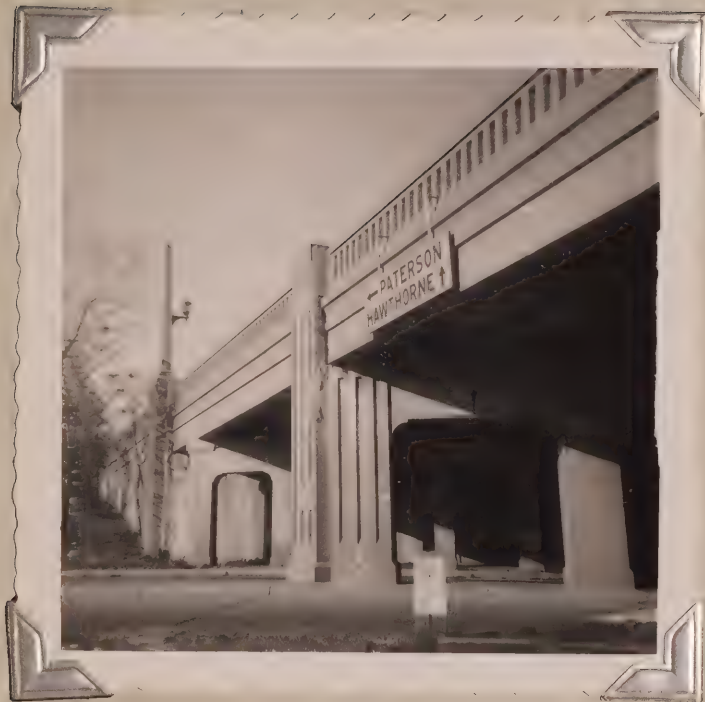
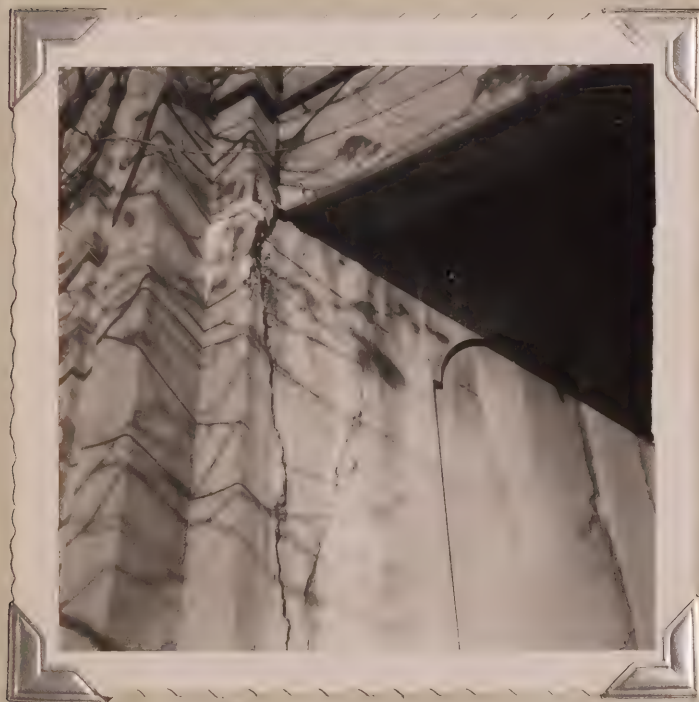
BRIDGE NO. 8

Condition - At the top of the abutments on the west end, vertical cracks appear at the bearings and in some areas the concrete has sloughed off at these locations. Considerable crystalline deposits under the approach spans. Vertical crack appears on west end abutment (see photo). Arches in sound condition. East end approach not as bad as west end. Some disintegration of concrete at the bearings on the east abutment.

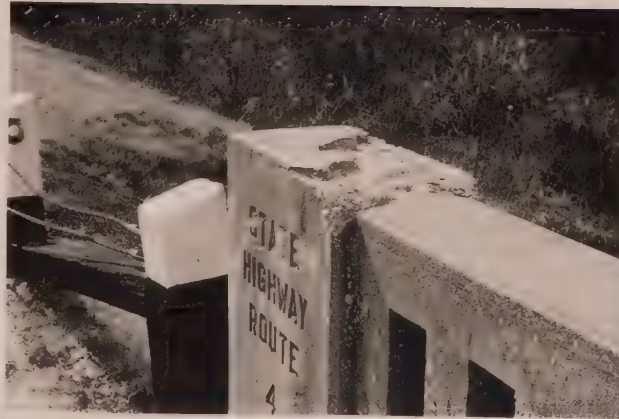
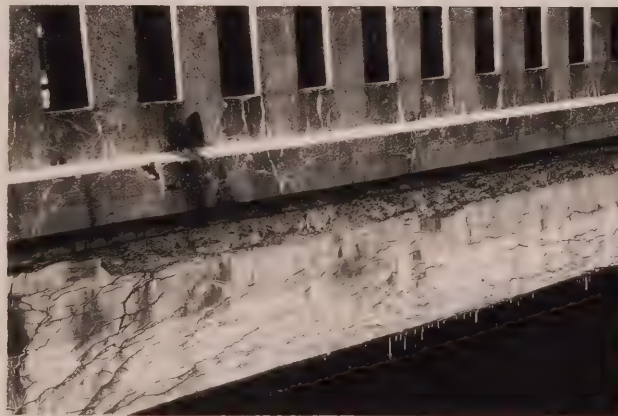
BRIDGE NO. 12

Condition - Concrete cover has come off the bottom reinforcing steel on one exterior girder. Disintegration of concrete on top of balustrade post. Crystalline deposits on face of exterior beams. See photos.

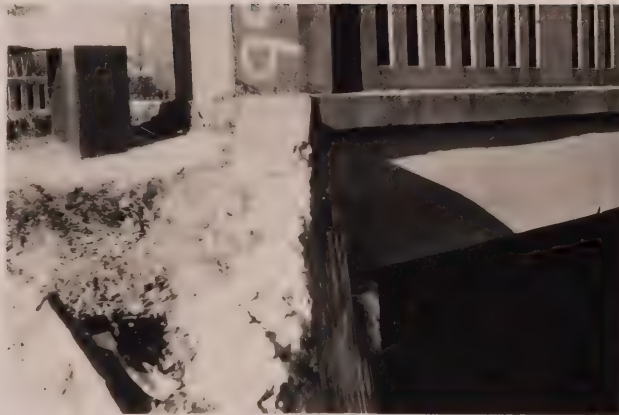
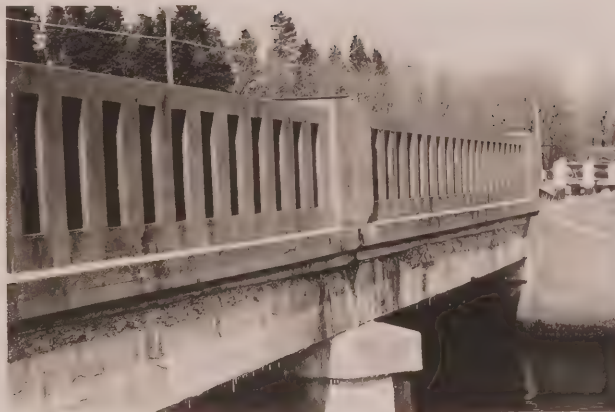
BRIDGE NO. 13

Condition - North wing walls in sound condition. Coping on south end wing walls badly disintegrated. Balustrades in good condition. Curb on upstream face disintegrated on south end. Upstream exterior girder shows some vertical cracking. abutments in sound condition. See photos.

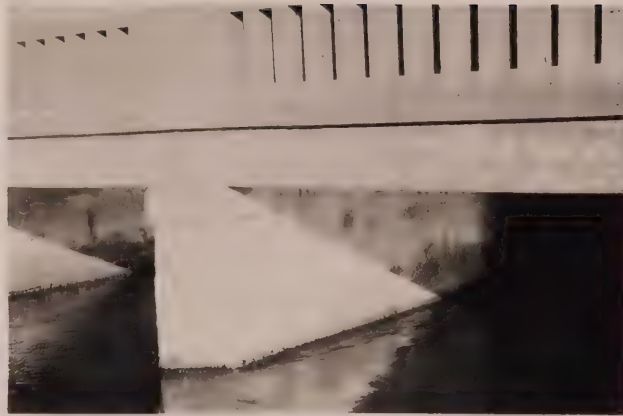
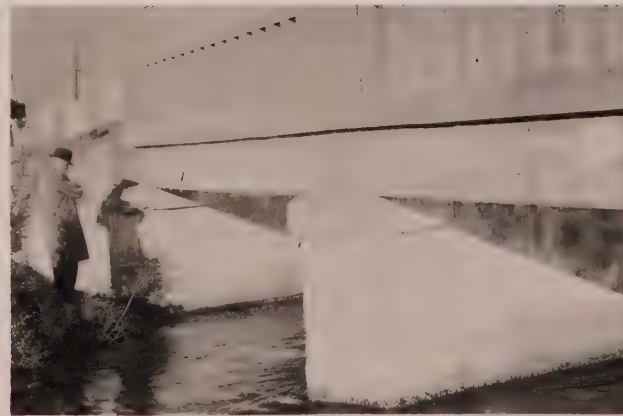
BRIDGE NO. 15

Condition - Concrete on pier on upstream face disintegrated. Coping on the abutment and coping on wing wall both at northwest corner have disintegrated. Cracking accompanied by crystalline deposits are prevalent throughout. On the balustrades reinforcing bars are exposed. Concrete is etched at the water level. See photos.

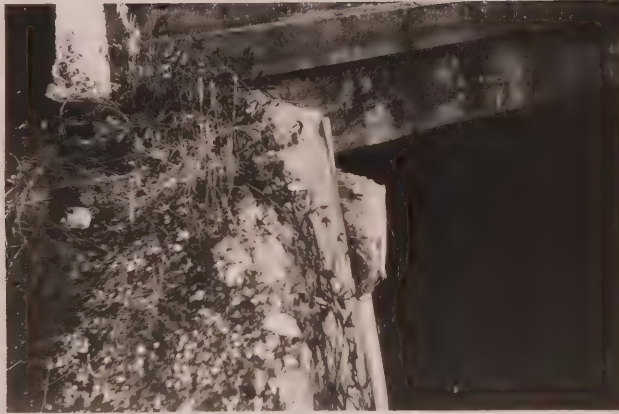
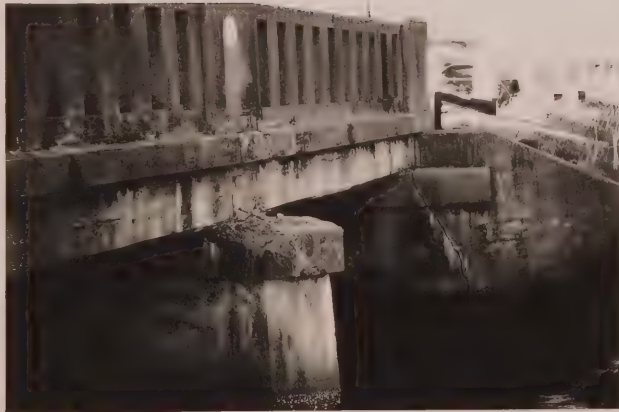
BRIDGE NO. 16

Condition - Pier tops on both sides of the bridge disintegrated coping on wing wall on southeast corner disintegrated. Large horizontal and vertical cracking on northeast wing wall. All vertical surface badly cracked accompanied by crystalline deposits. Concrete is etched at the water level. See photos.

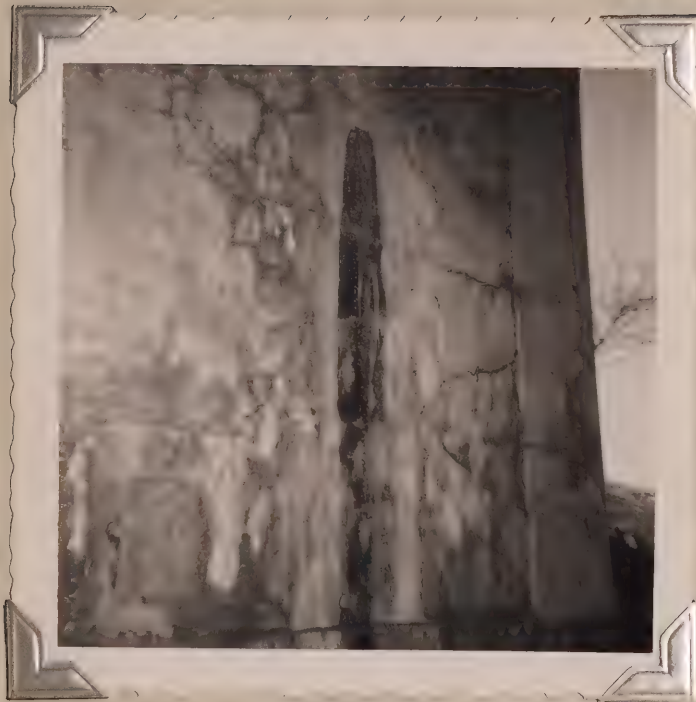
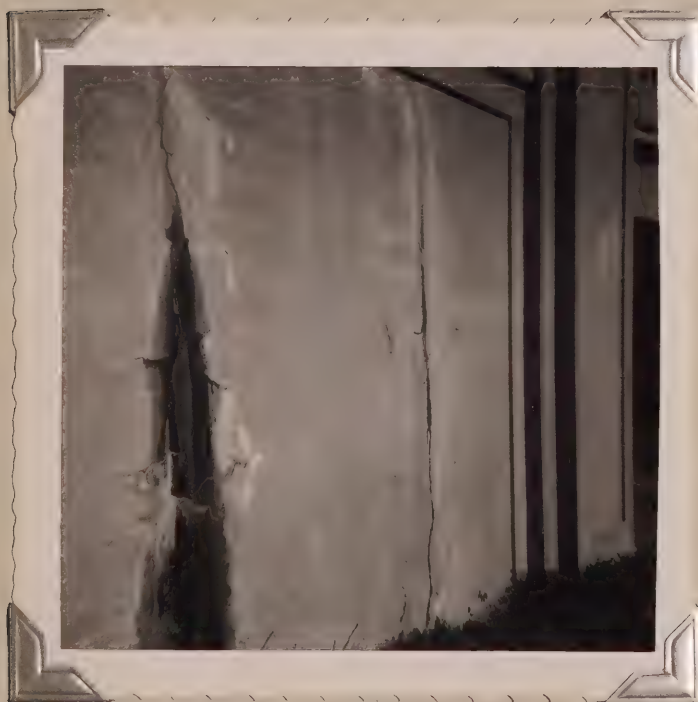
BRIDGE NO. 18

Condition - Concrete chipped away at bearings. Many cracks in face of north abutment accompanied by crystalline deposits. Poor drainage. See photo. Center pier and south abutment in sound condition.

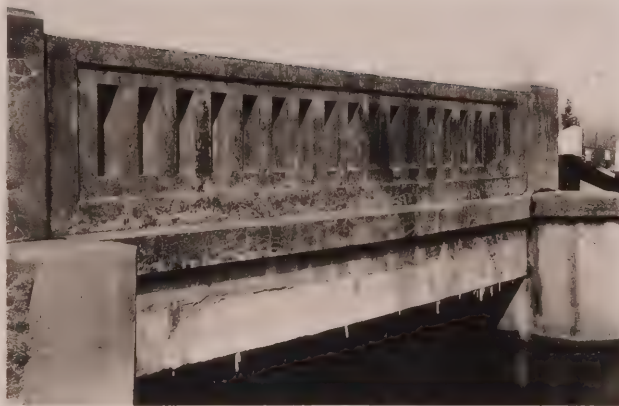
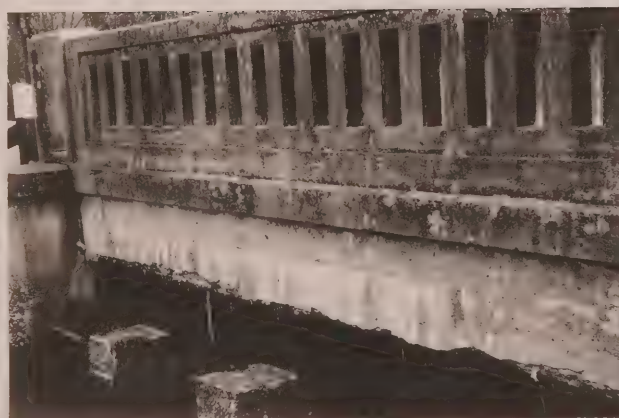
BRIDGE NO. 37

Condition - Wing wall coping at northeast corner disintegrated. All end posts of balustrade badly cracked. Wing wall on upstream face etched. Horizontal cracks at midheight of exterior girders accompanied by crystalline deposits.

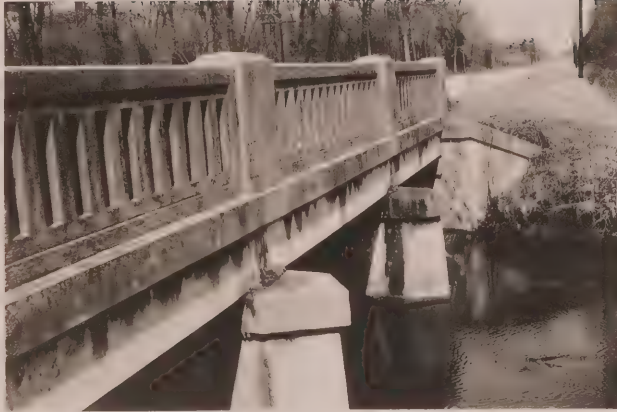
BRIDGE NO. 40

Condition - Etching of concrete at high water line.
Crystalline deposits on all exposed sur-
faces. See photos.

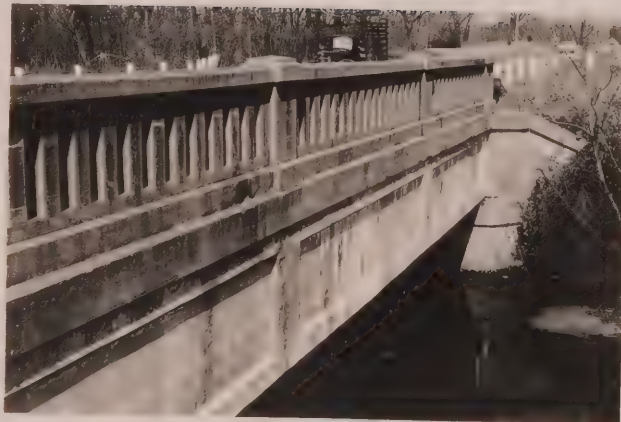
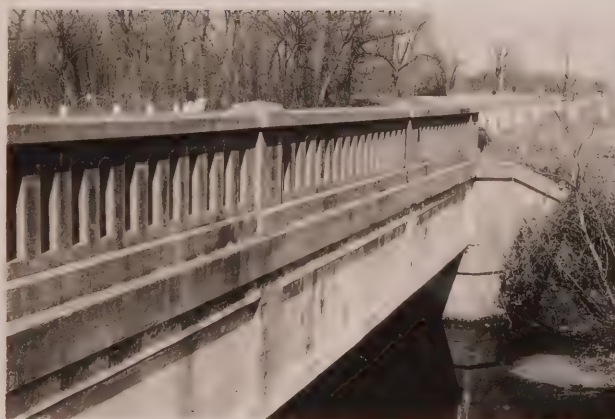
Condition - Underside of slab in good condition.
Downstream south side wing wall cracked,
probably due to movement. Otherwise, no
damage visible. No photos.

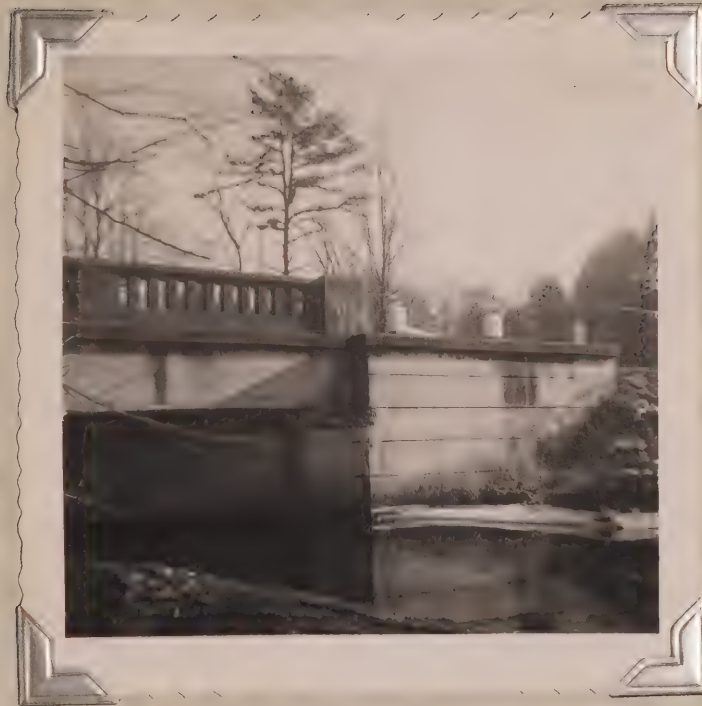
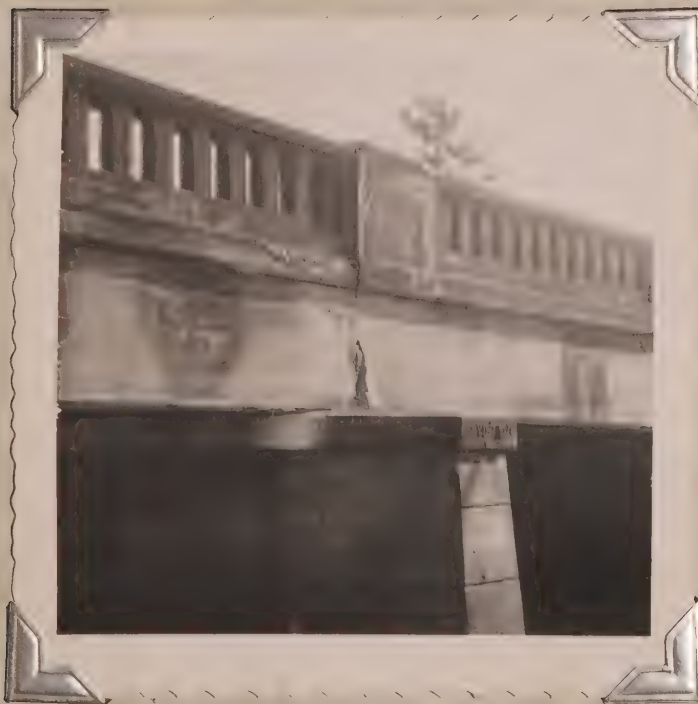
BRIDGE NO. 42

Condition - One vertical crack in pier and in both abutments. Top of post on balustrade on downstream side disintegrated. Exterior girders on downstream side cracked with some spalling. Disintegration of concrete at coping level of one abutment on downstream side. Crystalline deposits on underside of deck and side elevations of bridge. Upstream side of structure in good condition. See photos.
